DELAWARE RIVER BASIN
NISHISAKWICK CREEK
HUNTERDON COUNTY
NEW JERSEY

NISHISAKWICK CREEK DAM NJ 00129

PHASE 1 INSPECTION REPORT
NATIONAL DAM SAFETY PROGRAM

79 10 02 042
August, 1979

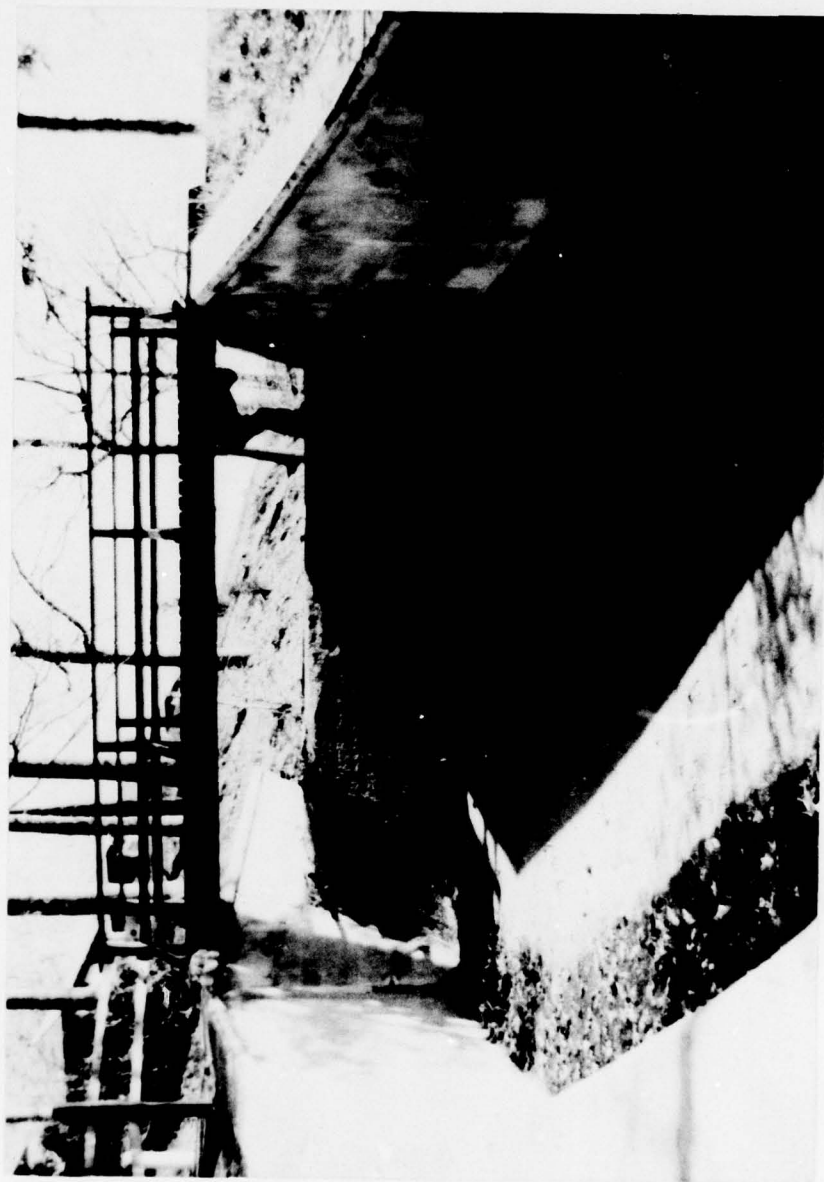
Nishisakwick Creek Dam
Overall view of spillway structure from downstream.

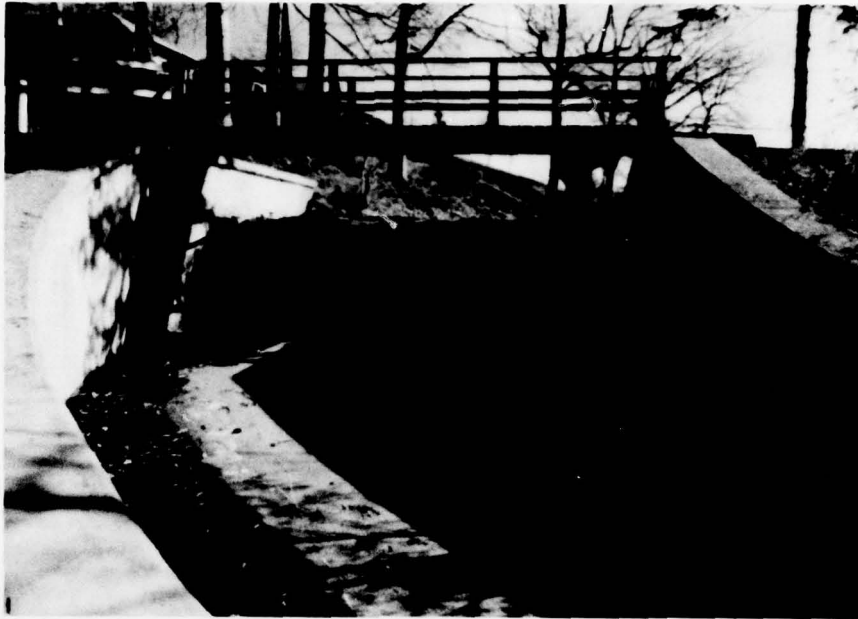
Photo No. 1 - Overall view of spillway and bridge structure from downstream. Note crack at joint of vertical and sloped right wing-wall, also seepage at the base of the spillway.

(3) Replacement of small quantities of eroded fill and riprap, and repair of minor cracks should be undertaken during routine maintenance.

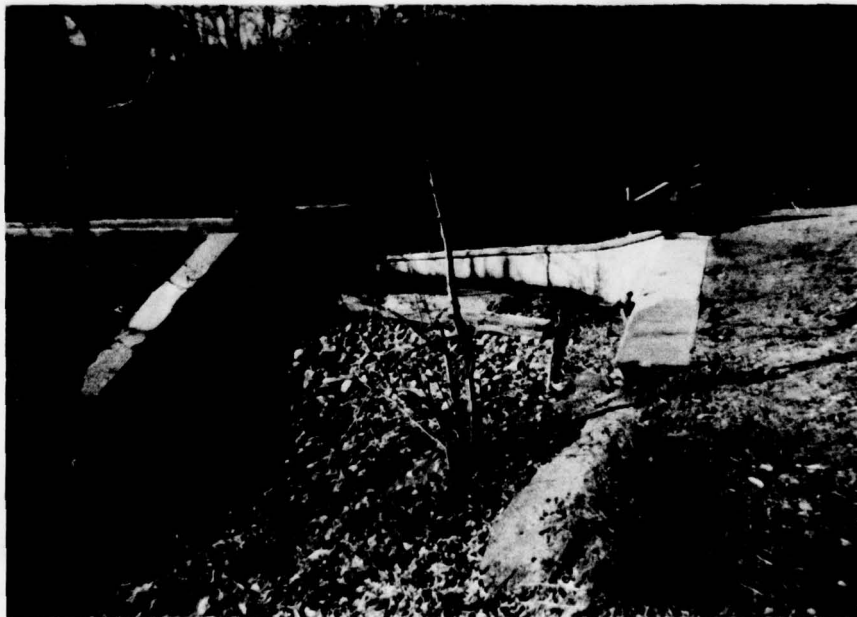
Photo No. 2 - Overall view of upstream face of spillway. Note build-up of stones and silt at the spillway inlet.

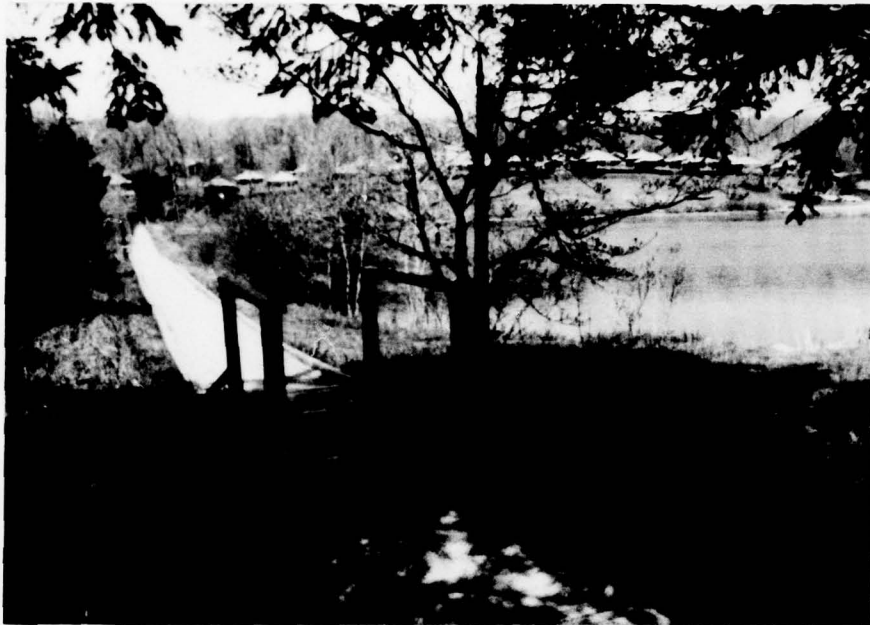
Photo No. 3 - View of concrete walkway along the crest and the emergency spillway. Note outlet pipe from the lake.

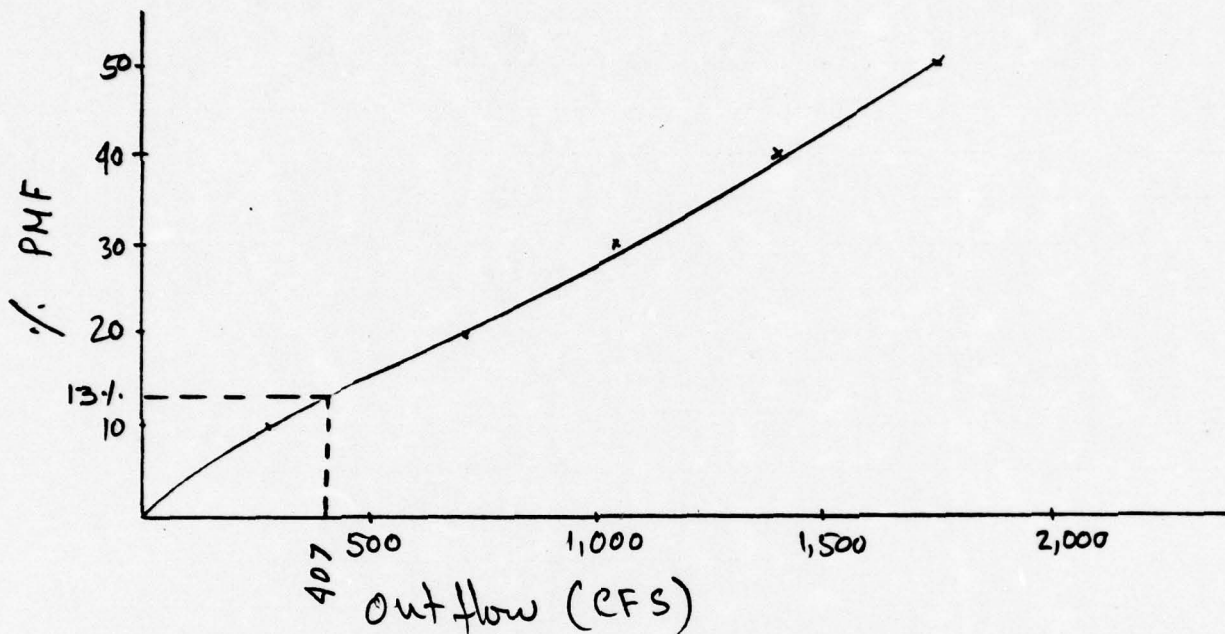
Overtopping Potential

Overtopping of Dam occurs at Ele 600
with $Q = 407$ cfs ($\approx 13\%$ of PMF)

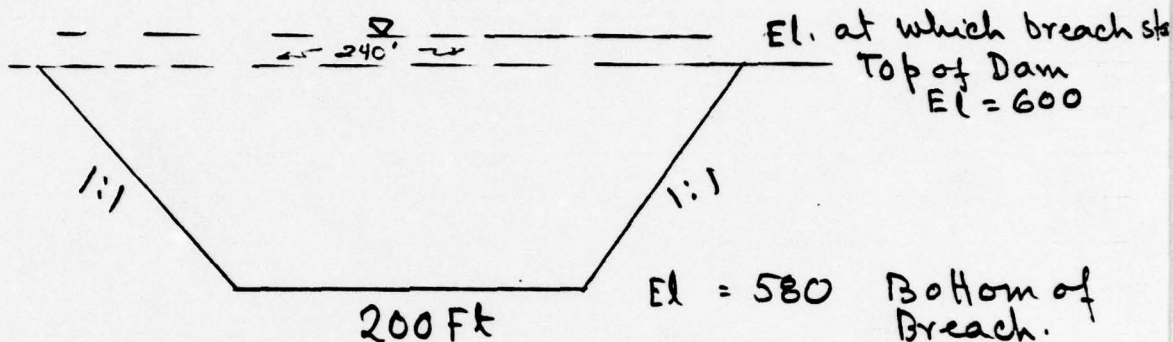
Breach Analysis

Assume breach begins to develop when
Reservoir stage reaches $\text{ele} = 600.3 \text{ Ft}$
i.e., 0.3 Ft above dam.

Effect of breach was analyzed at 2000 ft
downstream of breach.

No serious damage at 2000' downstream is
expected due to Dam break, but the
frequently occupied house 100' downstream
would be washed away, possibly causing
the loss of more than a few lives.
